Brussels, 26 January 2021

System separation in the Continental Europe Synchronous Area on 8 January 2021 – second update

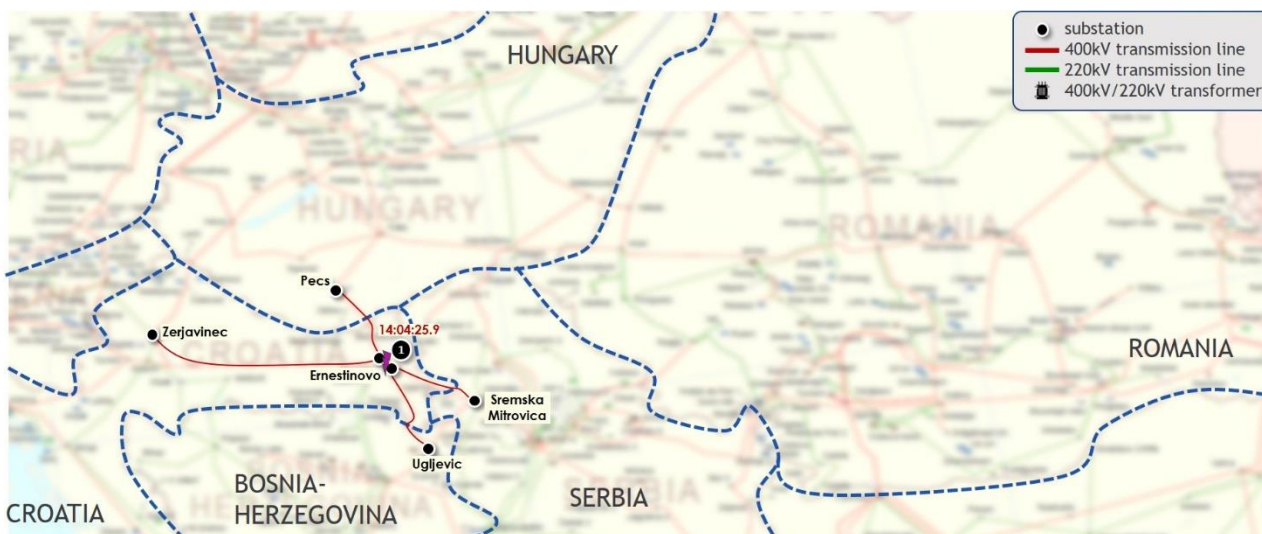
The analysed sequence of events concludes that the initial event was the tripping of a 400 kV busbar coupler in the substation Ernestinovo (Croatia) by overcurrent protection at 14:04:25.9. This resulted in a decoupling of the two busbars in the Ernestinovo substation, which in turn separated north-west and south-east electric power flows in this substation. As shown in Figure 1 below, north-west bound lines which remained connected to one busbar, connect Ernestinovo to Zerjavinec (Croatia) and Pecs (Hungary), while south-east bound lines which remained connected to another busbar, connect Ernestinovo to Ugljevik (Bosnia-Herzegovina) and Sremska Mitrovica (Serbia).

Figure 1 - Decoupling of two busbars in Ernestinovo

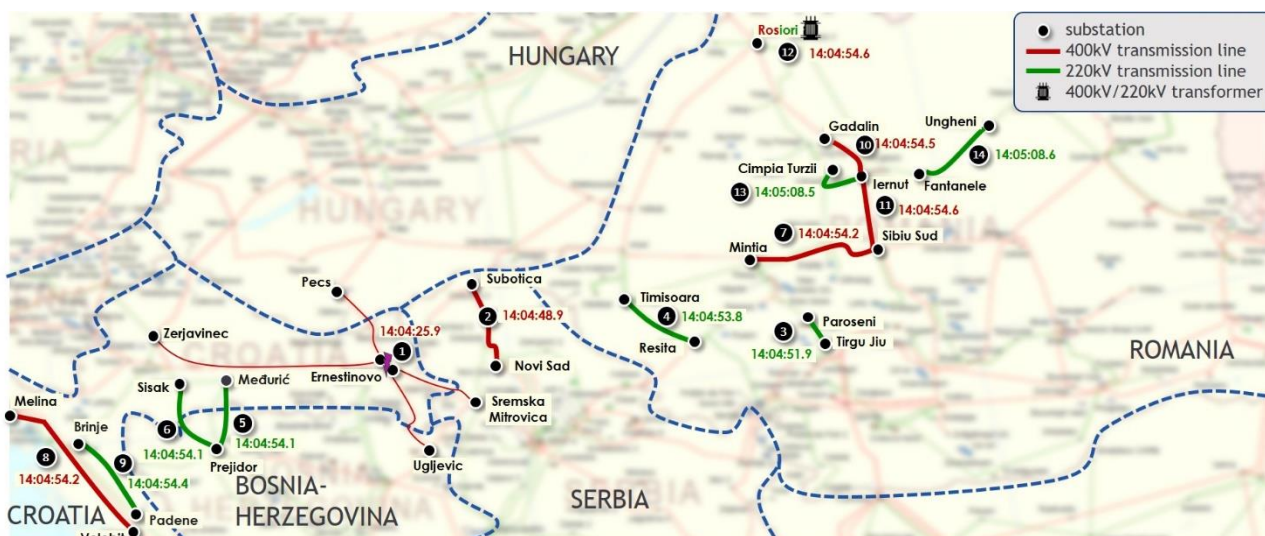
The separation of flows in the Ernestinovo substation, lead to the shifting of electric power flows to neighbouring lines which were subsequently overloaded. At 14:04:48.9, the line Subotica – Novi Sad (Serbia) tripped due to overcurrent protection. This was followed by the further tripping of lines due to distance protection, as shown in Figure 2, below, leading eventually to the system separation into two parts at 14:05:08.6.

Figure 2 - Tripping of additional transmission network elements after the decoupling of two busbars in Ernestinovo

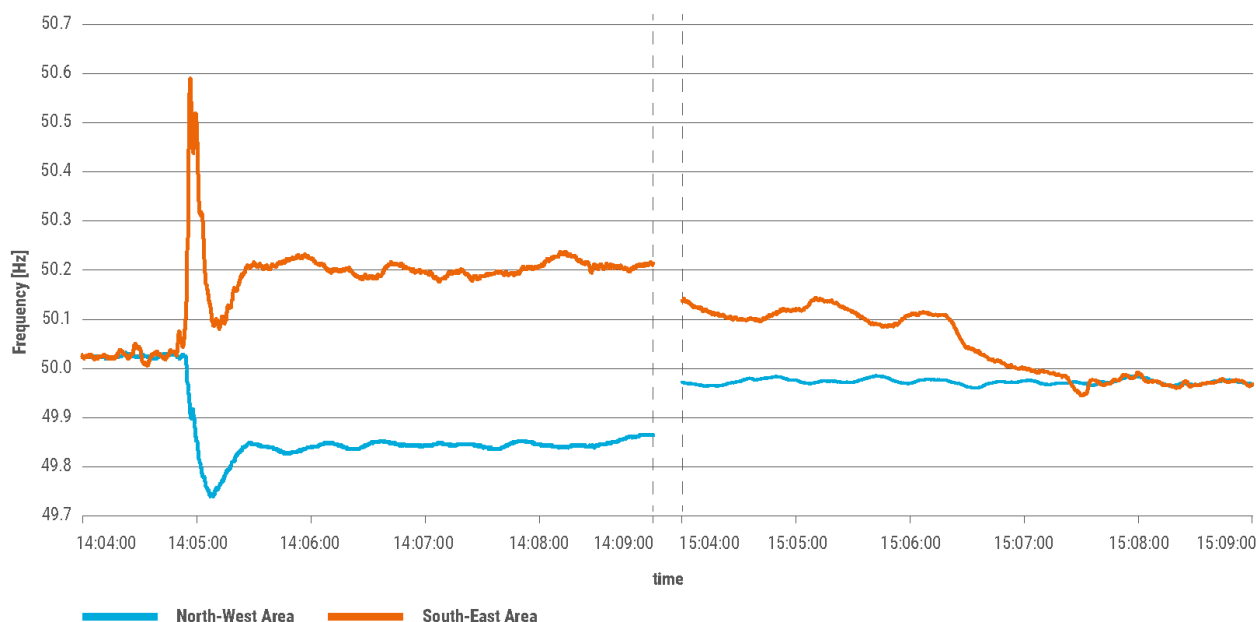
At approximately 14:05 CET, the frequency in the North-West Area initially decreased to a value of 49.74 Hz within a period of around 15 seconds before quickly reaching a steady state value of approximately 49.84 Hz. At the same time, the frequency in the South-East Area initially increased up to 50.6 Hz before settling at a steady state frequency between 50.2 Hz and 50.3 Hz as illustrated in Figure 4 below:

Figure 4 - Frequency in Continental Europe during the event on 8 January 2021 right after the disturbance and during resynchronisation

Due to the low frequency in the North-West Area, contracted interruptible services in France and Italy (in total around 1.7 GW) were disconnected in order to reduce the frequency deviation. These services are provided by large customers who are contracted by the respective Transmission System Operators (TSOs) to be disconnected if frequency drops under a certain threshold. In addition, 420 MW and 60 MW of supportive power were automatically activated from the Nordic and Great Britain synchronous areas respectively. These countermeasures ensured that already at 14:09 CET the frequency deviation from the nominal value of 50 Hz was reduced to around -0.1 Hz in the North-West area (Figure 4).

In order to reduce the high frequency in the South-East Area, automatic and manual countermeasures were activated, including the reduction of generation output (Eg. automatic disconnection of a 975 MW generator in Turkey at 14:04:57). As a consequence, the frequency in the South-East Area returned to 50.2 Hz at 14:29 CET and remained within control limits (49.8 and 50.2 Hz) until the resynchronisation of the two separated areas took place at 15:07:31.6 CET.

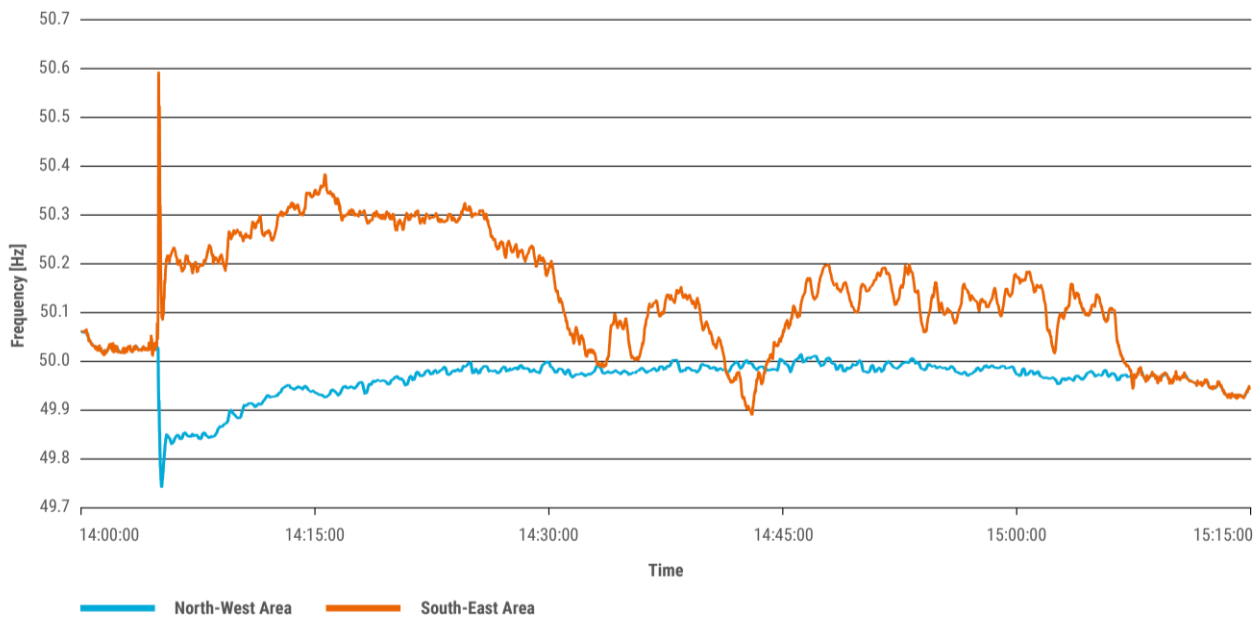
Between 14:30 CET and 15:06 CET the frequency in the South-East area was fluctuating between 49.9 Hz and 50.2 Hz due to the rather small size of the South-East Area where also several production units were disconnected (Figure 5). During this period, the frequency in the North-West Area fluctuated far less and remained close to the nominal value, due to the rather large size of the North-West Area. This frequency behaviour is a subject of further detailed investigation.

Figure 5 - Frequency in Continental Europe during the event on 8 January 2021 for the complete duration

The automatic response and the coordinated actions taken by the TSOs in Continental Europe ensured that the situation was quickly restored close to normal operation. The contracted interruptible services in Italy and in France were reconnected at 14:47 CET and 14:48 CET respectively prior to the resynchronisation of the North-West and South-East areas at 15:08 CET.
